# BIO CLAMP™ TEST REPORT

To conduct pressure and torque testing of the Bio Clamps as specified in the Clamp Testing Protocol (TR2077001) and report the findings.

Runfold Medical Ltd (RML) was asked by Bio Pure Technology Ltd to undertake non destructive & destructive testing of the Bio Pure Bio Clamps an all available sizes from three (3) separate batches.

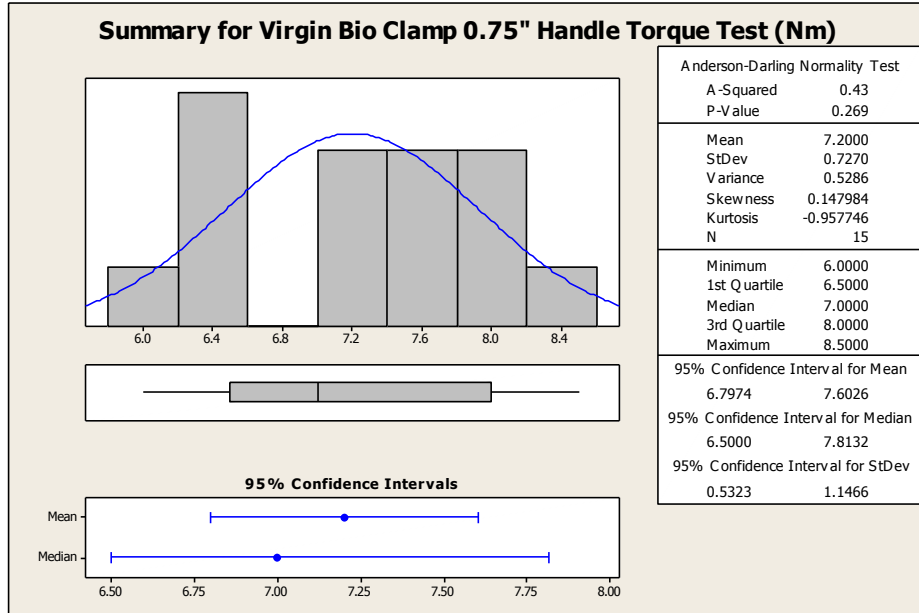
**Figure 8.3.1 – Summary of Results for 0.75" Virgin Bio Clamp**

All Bio Clamps in all sizes from batches 1 – 3 and the additional 4.0" clamps displayed an average torque value at the point of failure of between 7Nm and 11Nm.

Clamp Type	Clamp Size	Mean Average Force at Failure (Nm)
Virgin Clamp	0.75"	7.200
Virgin Clamp	1.5"	8.633
Virgin Clamp	2.0"	7.266
Virgin Clamp	2.5"	9.466
Virgin Clamp	3.0"	8.833
Virgin Clamp	4.0"	10.200
Additional Virgin Clamp	4.0"	8.200
Autoclaved Clamp	0.75"	7.667
	1.5"	8.166
<b>Autoclaved Clamp</b>		
Autoclaved Clamp	2.0"	8.133
Autoclaved Clamp	2.5"	8.233
Autoclaved Clamp	3.0"	8.933
Autoclaved Clamp	4.0"	11.233
Additional Autoclaved Clamp	4.0"	12.033
Gamma Irradiated Clamp	0.75"	7.500
Gamma Irradiated Clamp	1.5"	8.300
Gamma Irradiated Clamp	2.0"	7.466
Gamma Irradiated Clamp	2.5"	7.933
Gamma Irradiated Clamp	3.0"	7.667
Gamma Irradiated Clamp	4.0"	11.333
Additional Gamma Irradiated Clamp	4.0"	11.966

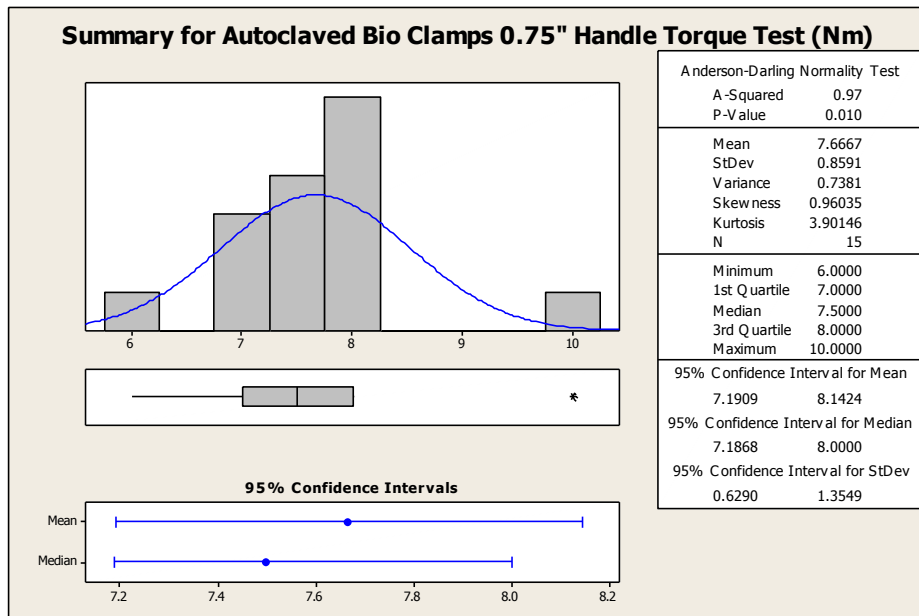
**Figure 8.3.2 – Summary of Results for 0.75" Autoclaved Bio Clamp**

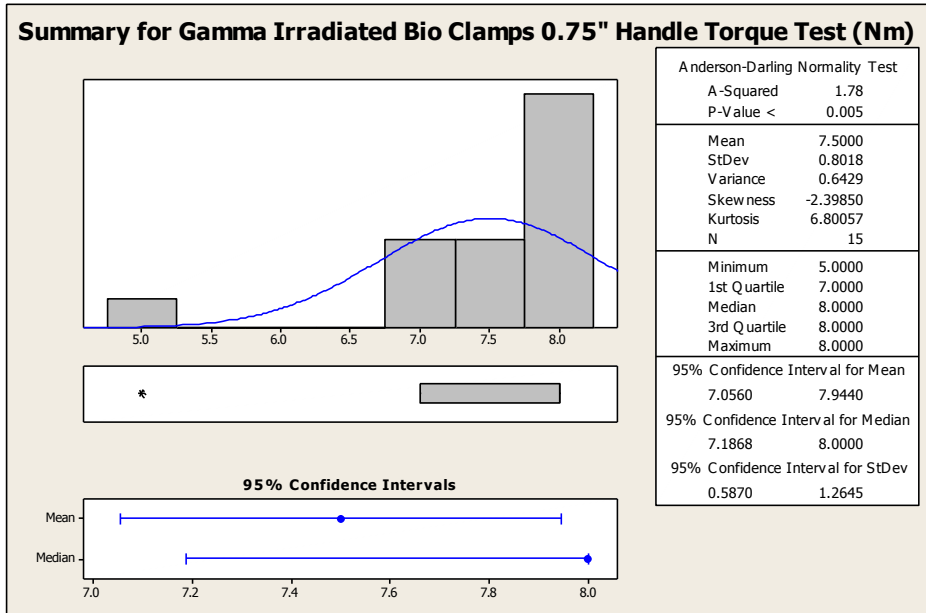
Figure 8.3.3 – Summary of Results for 0.75" Gamma Irradiated Bio Clamp

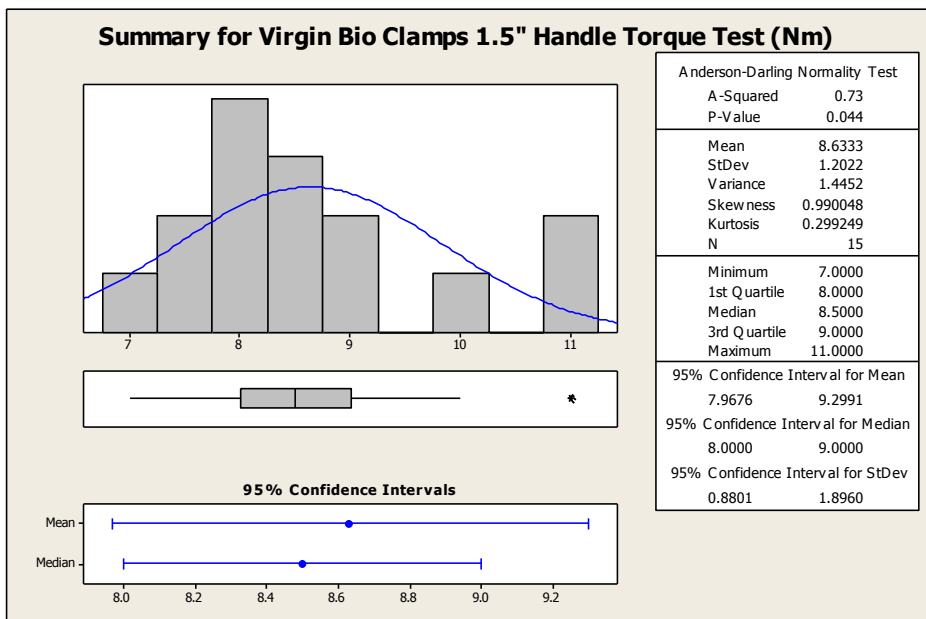
Figure 8.3.4 – Summary of Results for 1.5" Virgin Bio Clamp

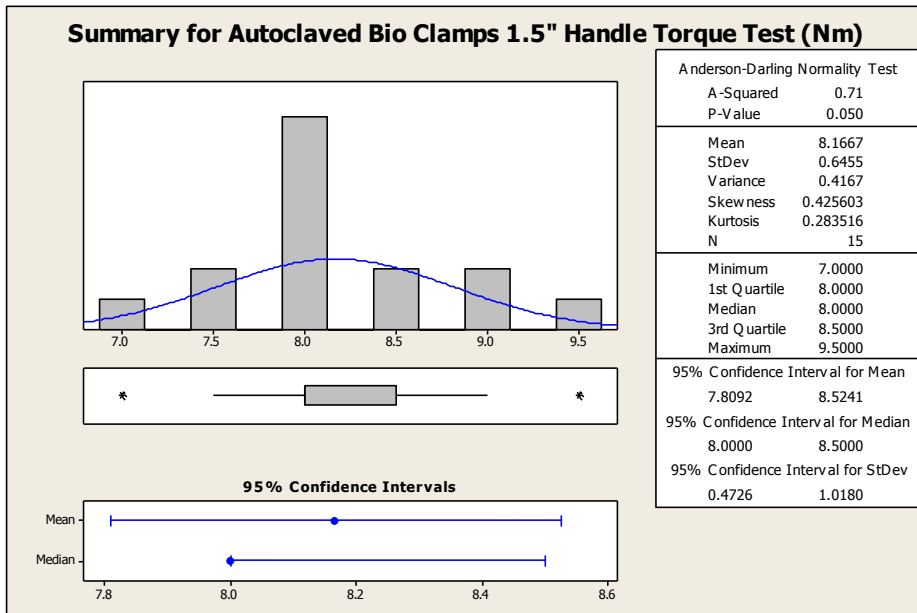
**Figure 8.3.5 – Summary of Results for 1.5" Autoclaved Bio Clamp**

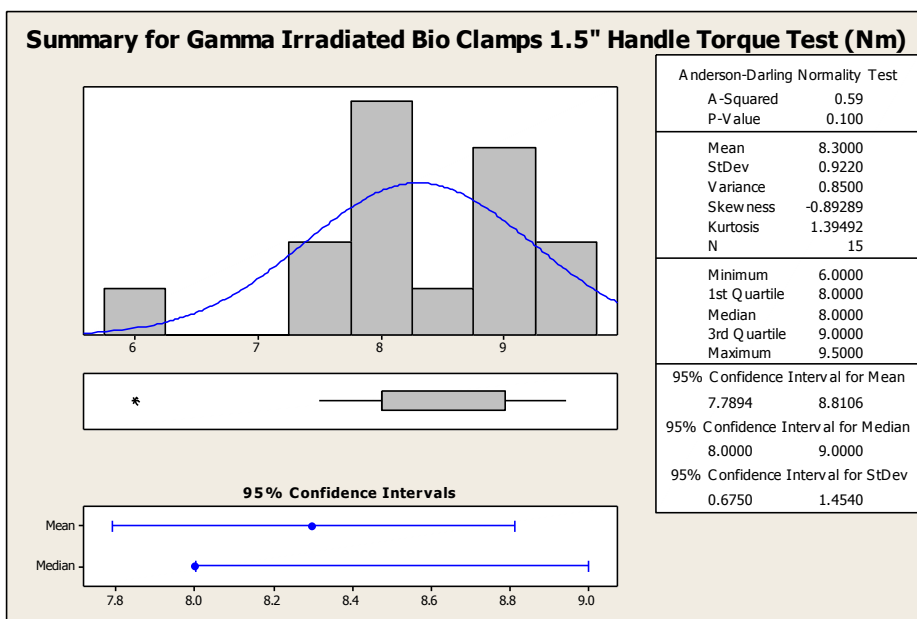
**Figure 8.3.6 – Summary of Results for 1.5" Gamma Irradiated Bio Clamp**

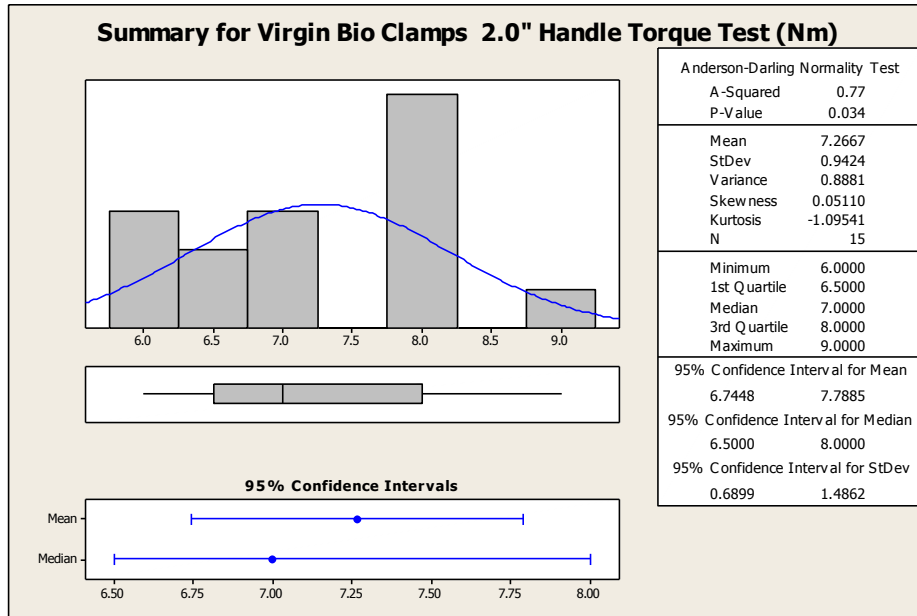
Figure 8.3.7 – Summary of Results for 2.0" Virgin Bio Clamp

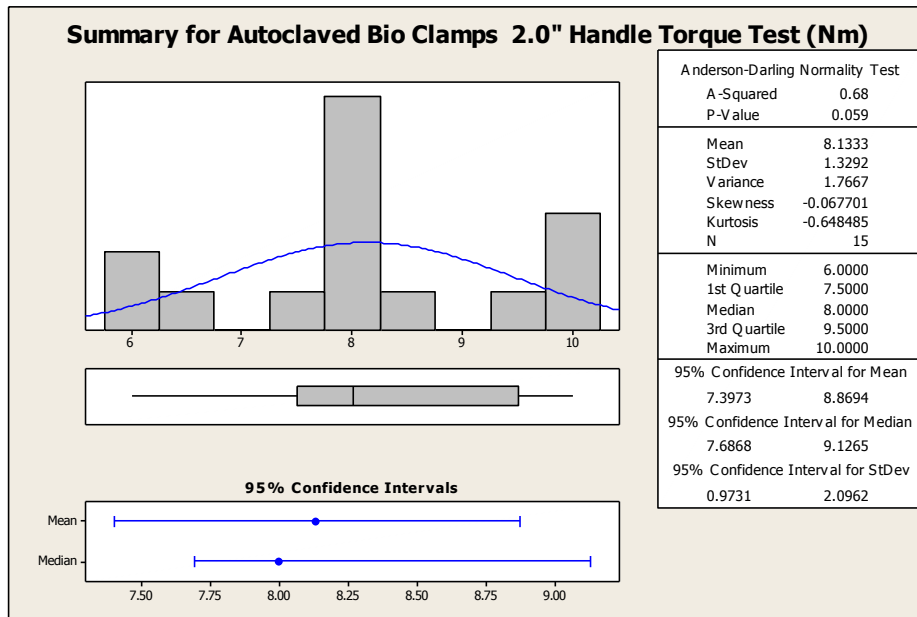
Figure 8.3.8 – Summary of Results for 2.0" Autoclaved Bio Clamp

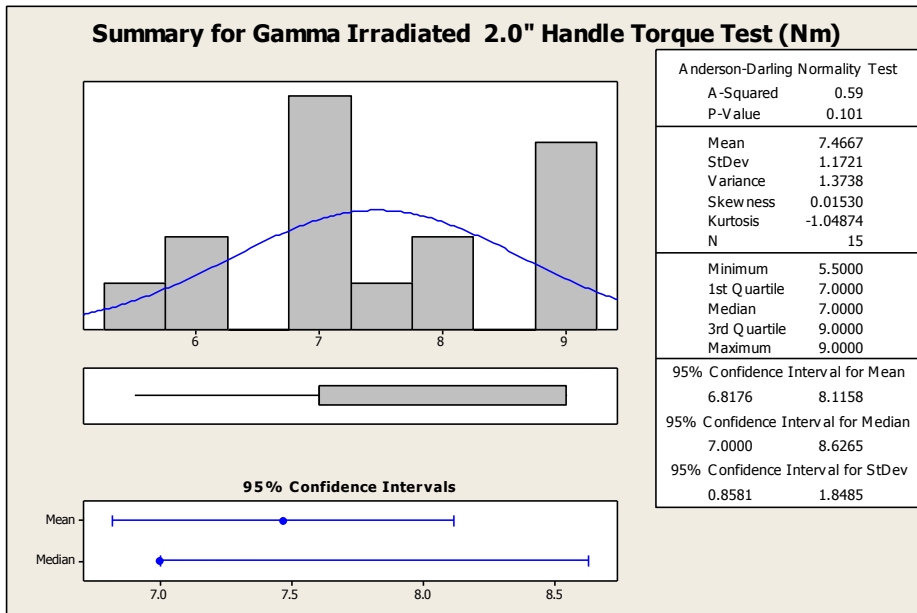
**Figure 8.3.9 – Summary of Results for 2.0" Gamma Irradiated Bio Clamp**

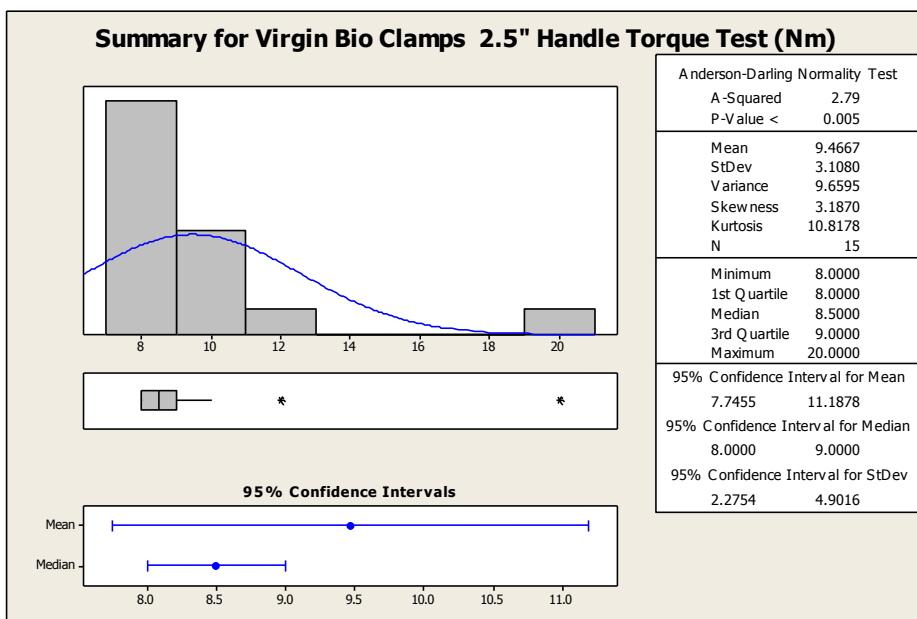
**Figure 8.3.10 – Summary of Results for 2.5" Virgin Bio Clamp**

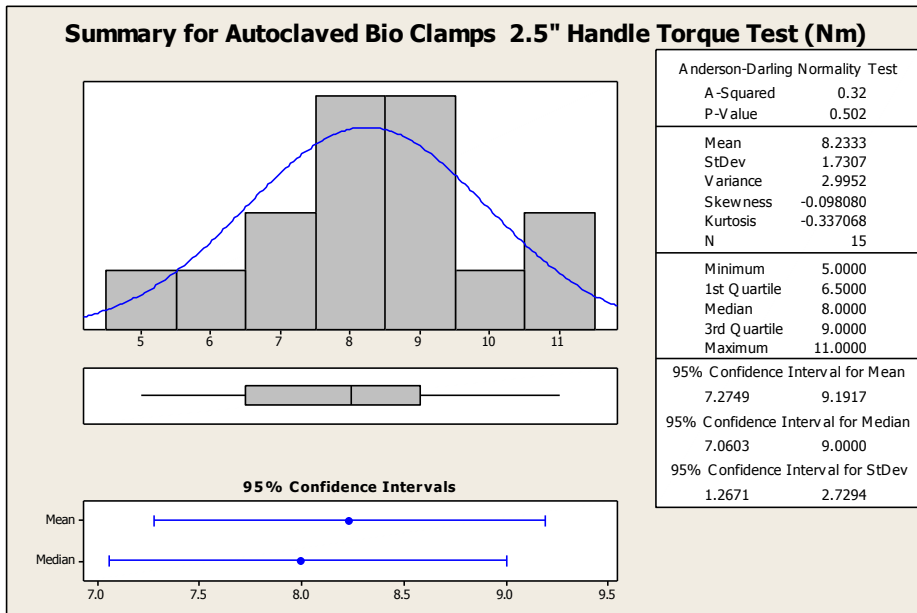
**Figure 8.3.11 – Summary of Results for 2.5" Autoclaved Bio Clamp**

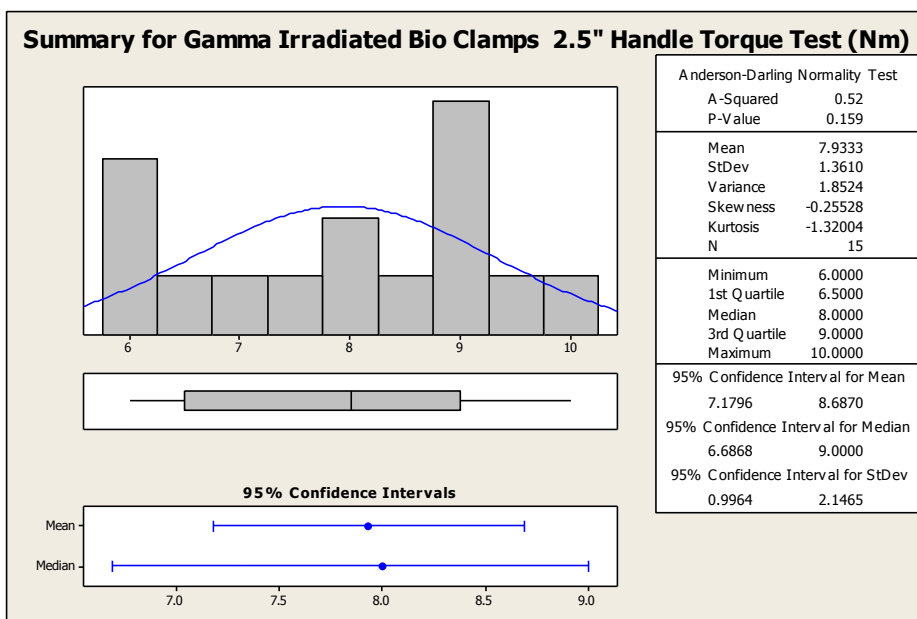
**Figure 8.3.12 – Summary of Results for 2.5" Gamma Irradiated Bio Clamp**

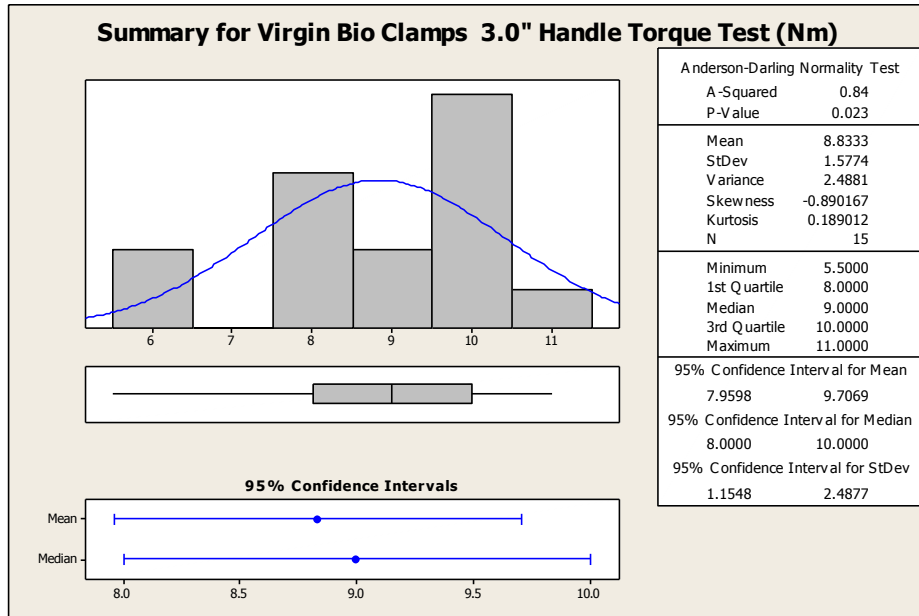
Figure 8.3.13 – Summary of Results for 3.0" Virgin Bio Clamp

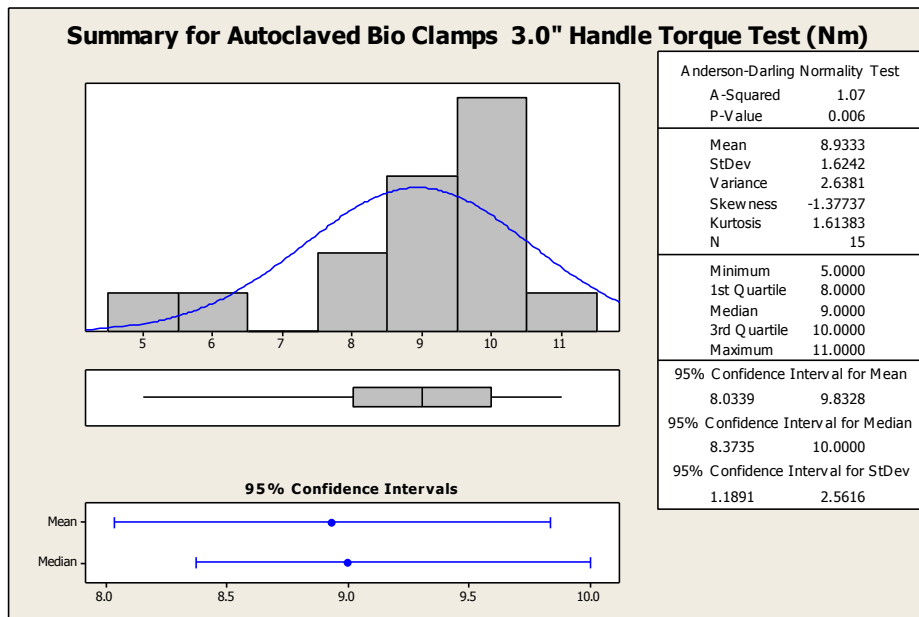
Figure 8.3.14 – Summary of Results for 3.0" Autoclaved Bio Clamp

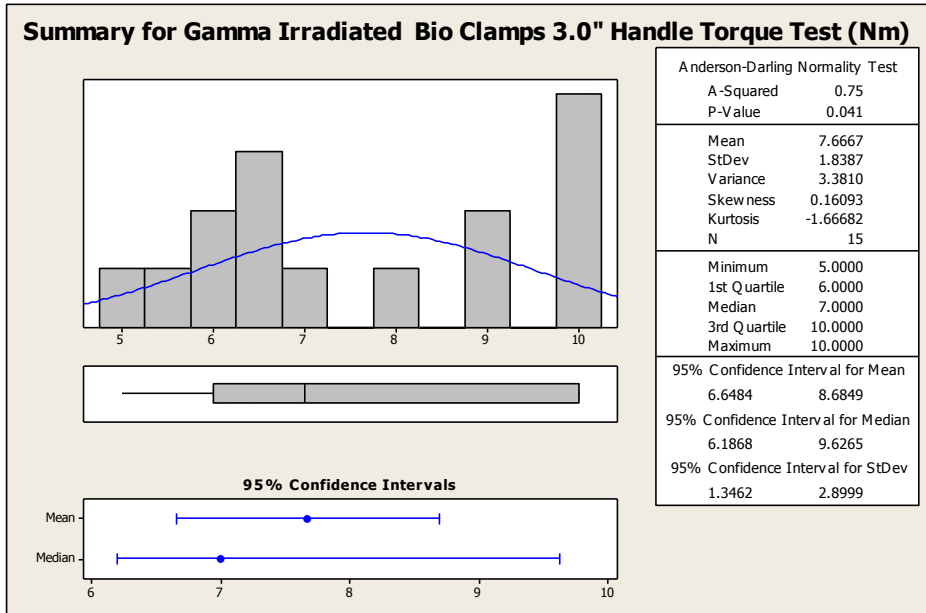
**Figure 8.3.15 – Summary of Results for 3.0" Gamma Irradiated Bio Clamp**

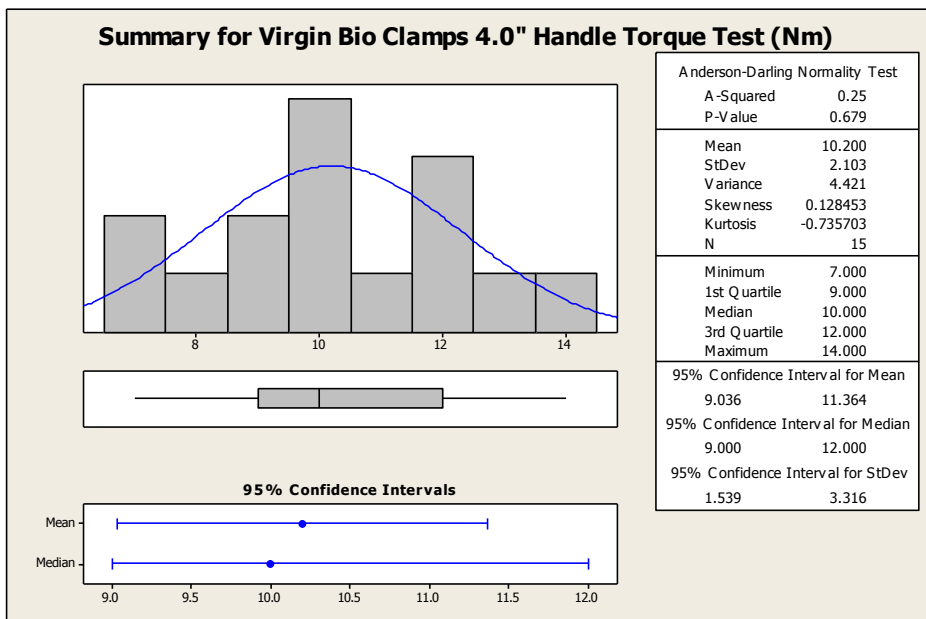
**Figure 8.3.16 – Summary of Results for 4.0" Virgin Bio Clamp**

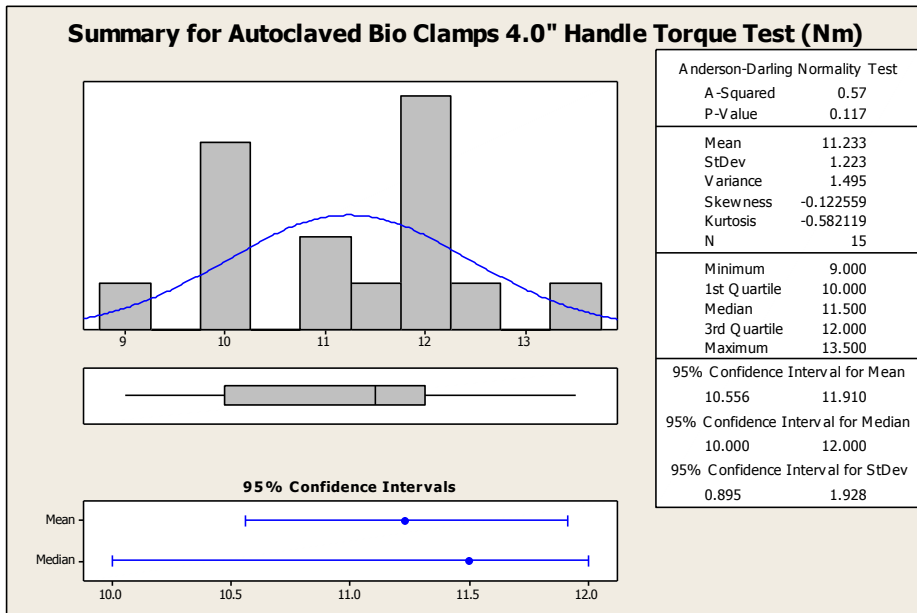
**Figure 8.3.17 – Summary of Results for 4.0" Autoclaved Bio Clamp**

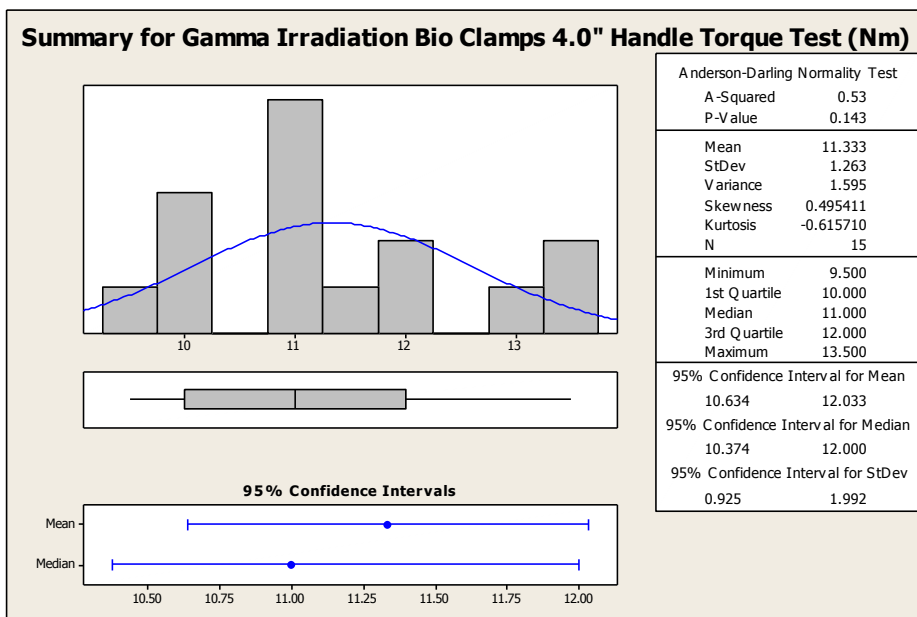
**Figure 8.3.18 – Summary of Results for 4.0" Gamma Irradiated Bio Clamp**

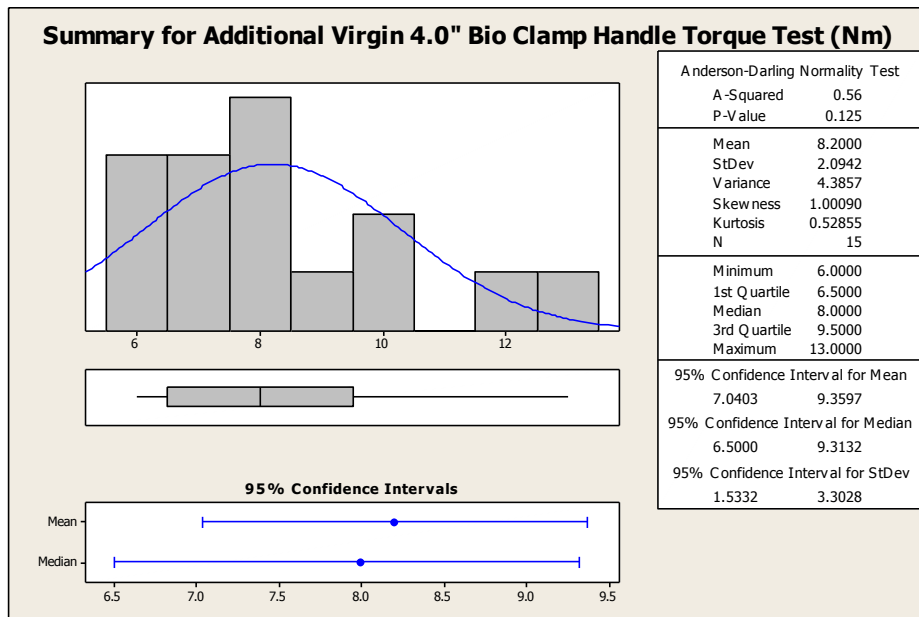
Figure 8.3.19 – Summary of Results for Additional 4.0” Virgin Bio Clamps

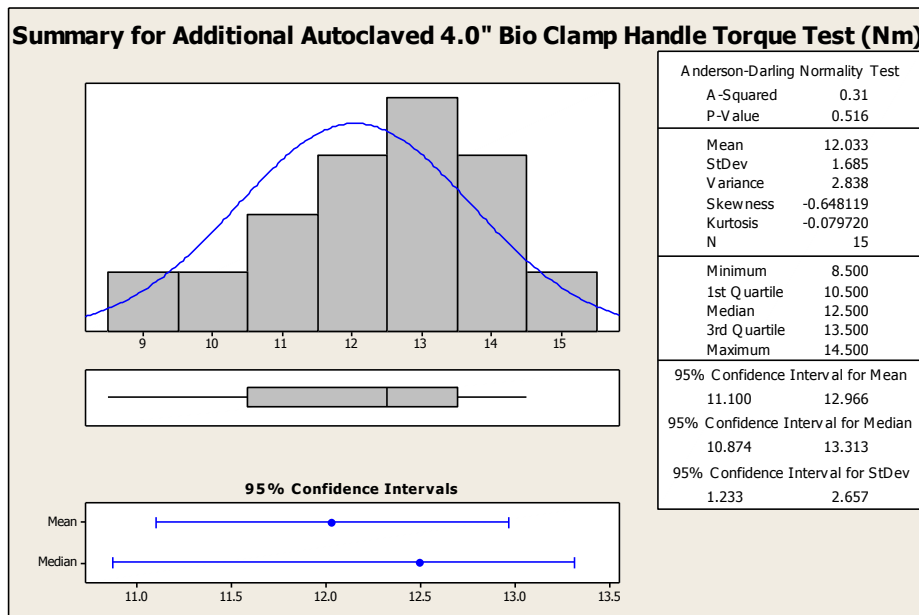
Figure 8.3.20 – Summary of Results for Additional 4.0” Autoclaved Bio Clamps

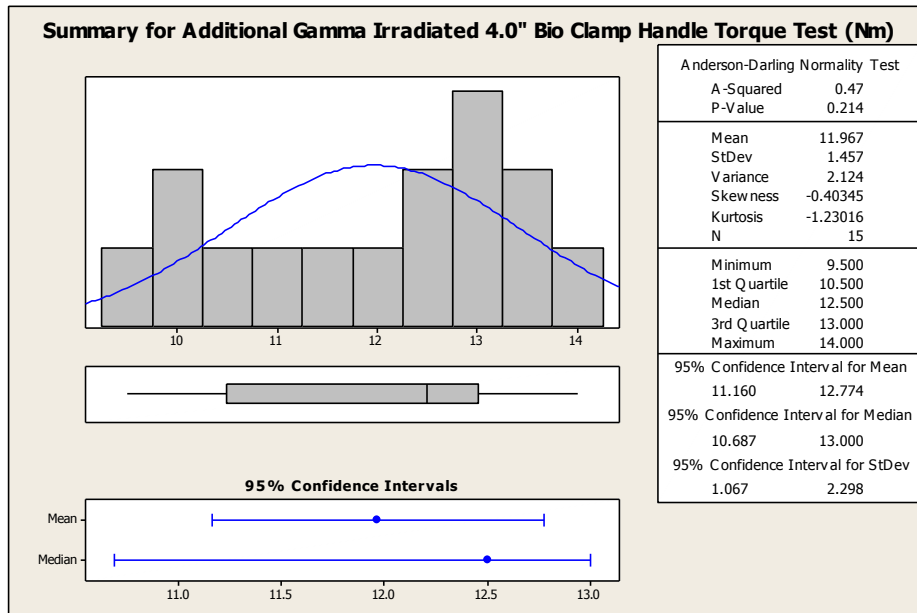
**Figure 8.3.21 – Summary of Results for Additional 4.0" Gamma Irradiated**
